# **Phase II Environmental Site Assessment Report**

**Mifflin County Industrial Development Corporation  
Recreation Site  
and  
Plaza Site  
Granville Township, PA**

**Corkins Property  
Borough of Lewistown, PA**

ARM Project 02242

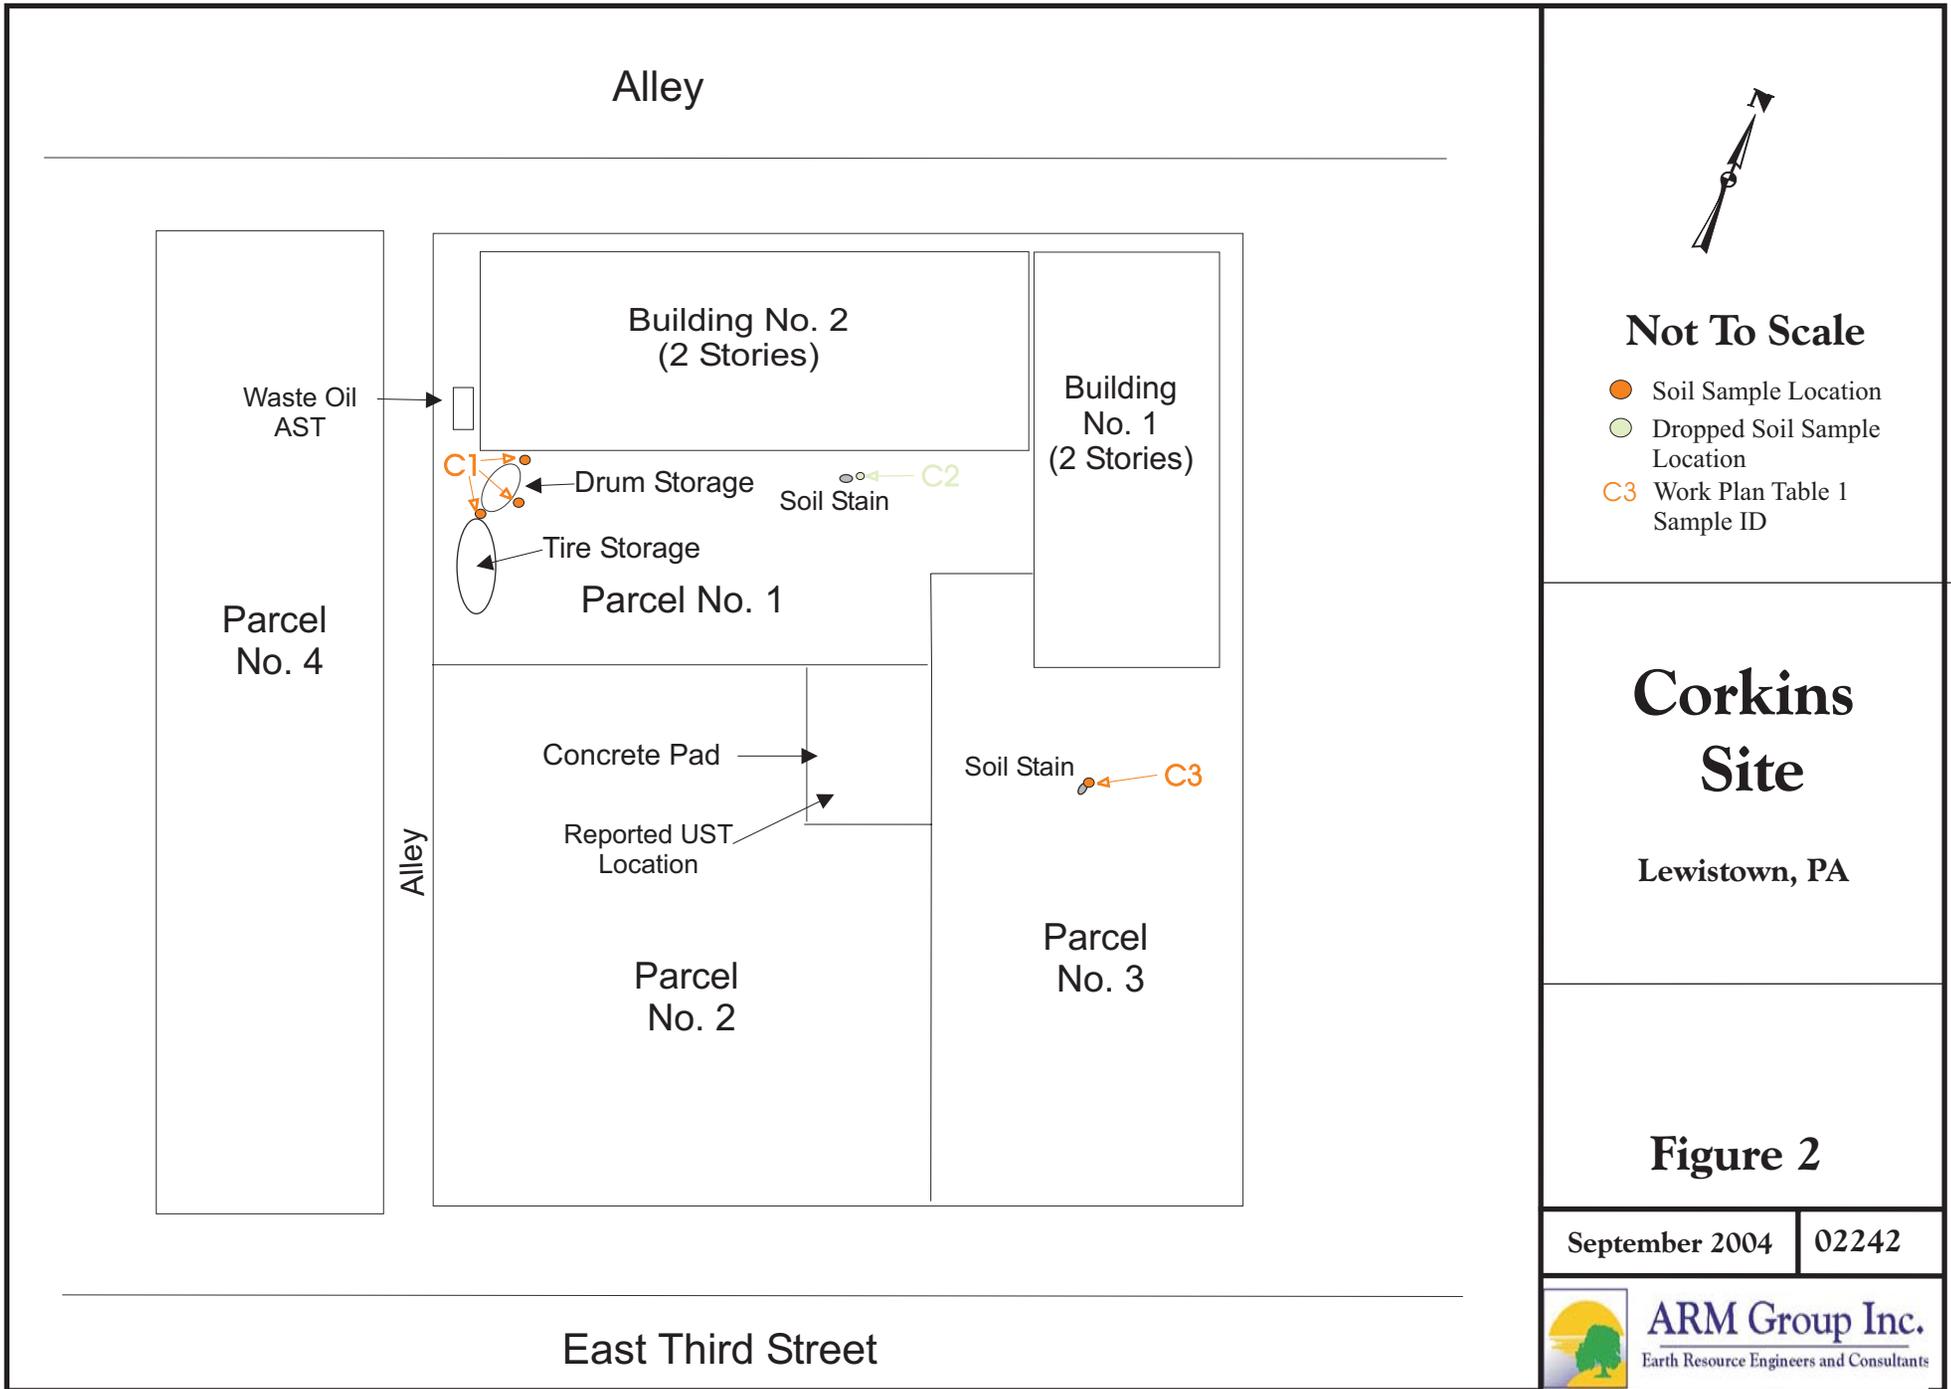
Two soil samples were collected from the site on October 23, 2003. The sampling results are summarized on the attached Table 1, and the approximate sampling locations are shown on the attached figure (Figure 2). No staining or other evidence of potential contamination was identified in the vicinity of proposed sampling location C-2, and therefore no sample was collected from this location.

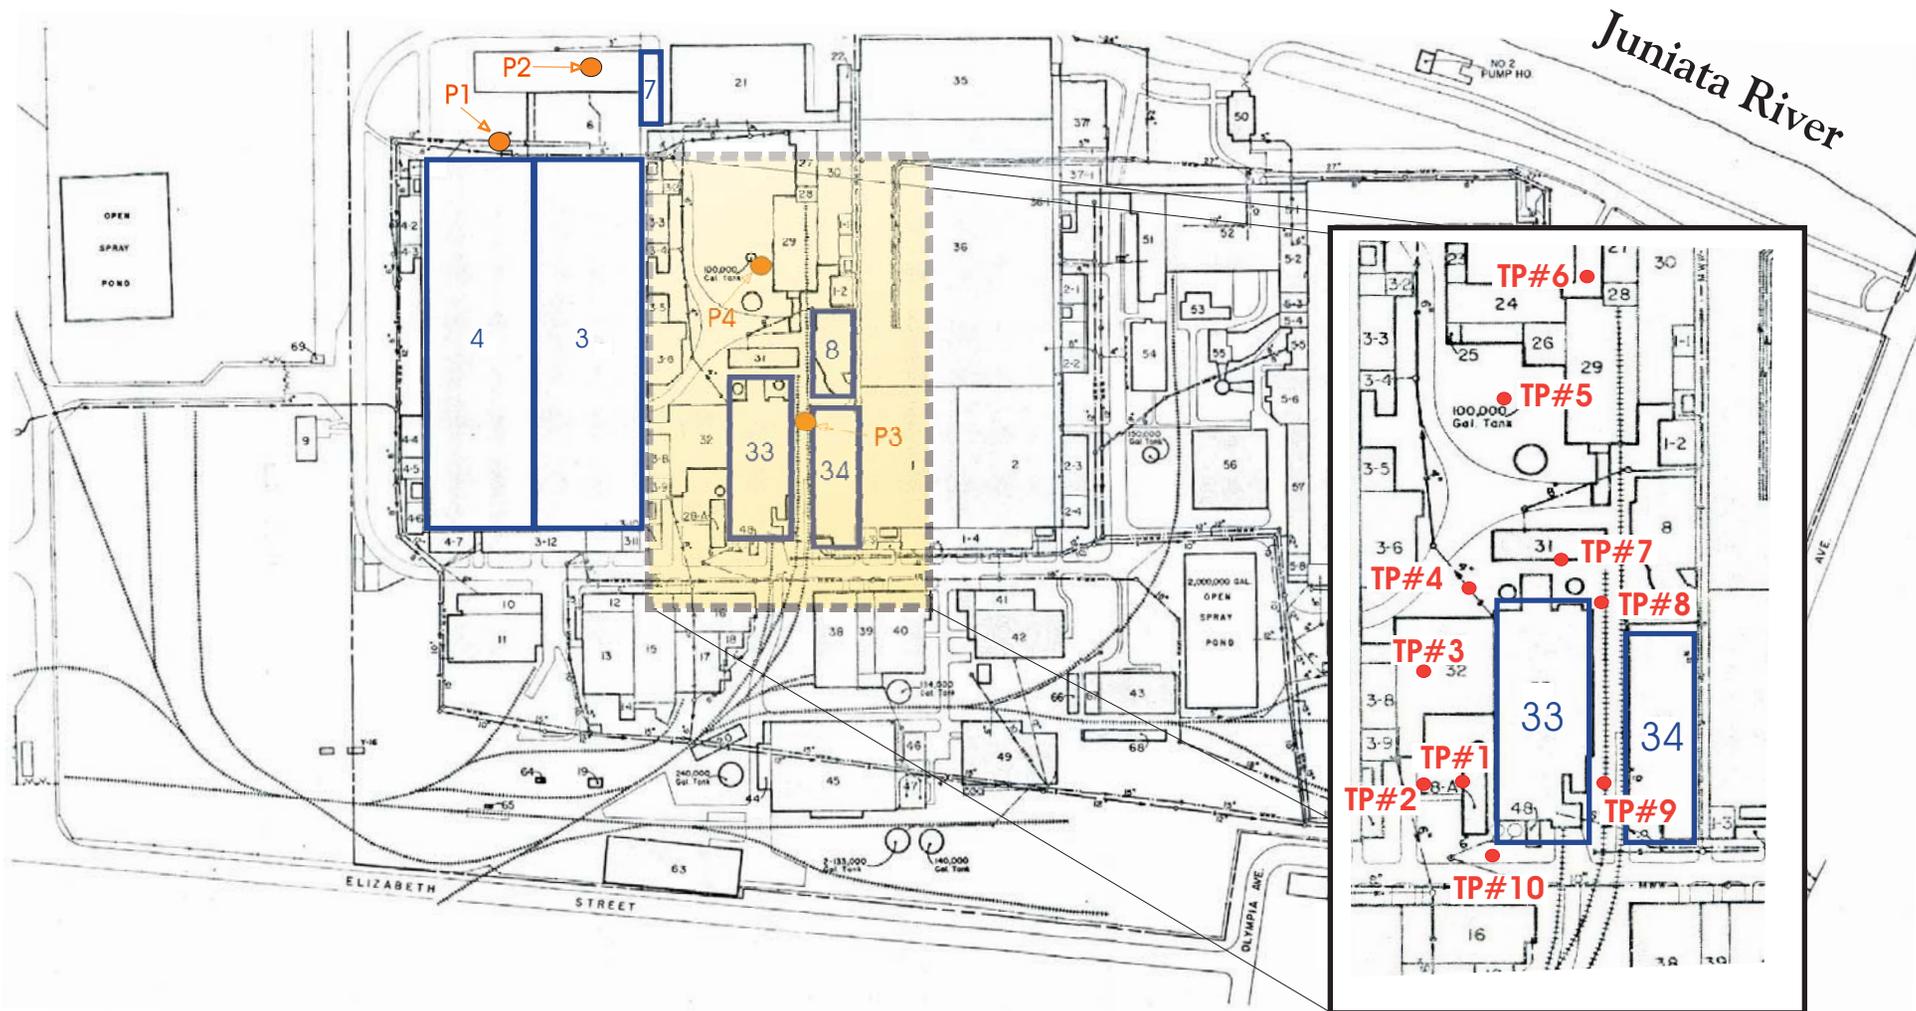
Enlargement of P3 Sampling Area

The areas of the site that were investigated included: a wastewater subsidence basin at Building 7; rubble fill materials and soil east of Building 3; stained soil next to a transformer pad at Building 4; and, soil beneath the water tower (see Figure 3 for test pit and soil sample locations). In addition, because of the historic use of significant quantities of hazardous/regulated materials at the site, and the resultant possibility of on-site spills or disposal of such materials, some subsurface investigation of the unpaved Plaza exterior areas was also performed. Potential sample locations in these areas were selected during a pre-investigation site visit, the purpose of which was to familiarize sampling personnel with the site features, including the health and safety issues, and to identify areas most likely to exhibit contamination.

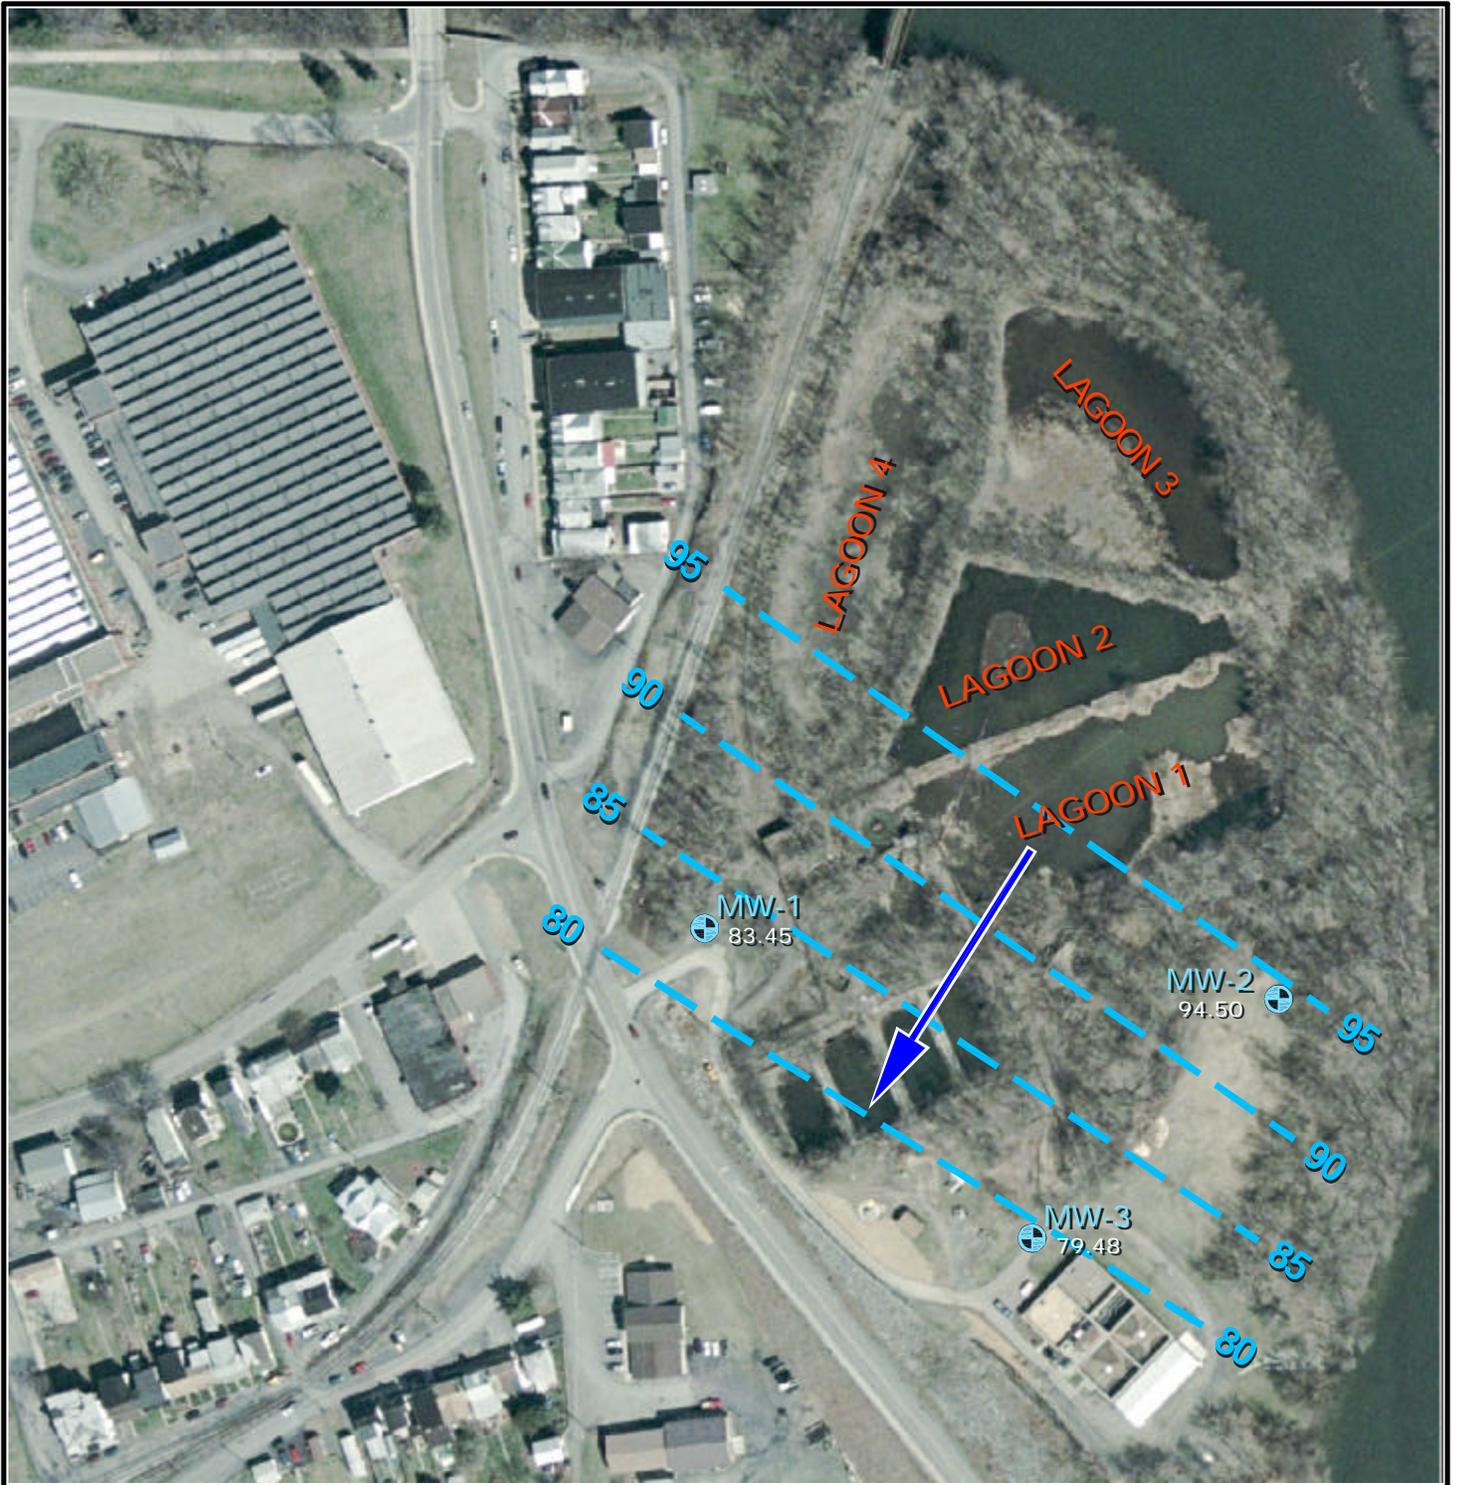
GROUNDWATER ELEVATION BASED ON AN ASSUMED VERTICAL DATUM OF 100 FT. MSL AT THE GROUND SURFACE OF MW-1.

Three groundwater monitoring wells were installed as part of the Phase II investigation at the Recreation site. As presented in the Work Plan for the Recreation Site, the groundwater monitoring well locations were selected so as to assess the upgradient and downgradient groundwater conditions with respect to the lagoons. The upgradient and downgradient locations were estimated based on anticipated site conditions. However, due to field conditions and site access restrictions, the groundwater monitoring well locations needed to be adjusted; Well MW-2 was shifted approximately 300 feet south of the proposed location, and Well MW-3 was shifted approximately 250 feet southwest of the initially proposed location (see Figures 4, 5 and 6). These adjustments were made following EPA approval.
